## Saint Peters Episcopal Church Rectory Report

June 30, 2008

## Report Summary

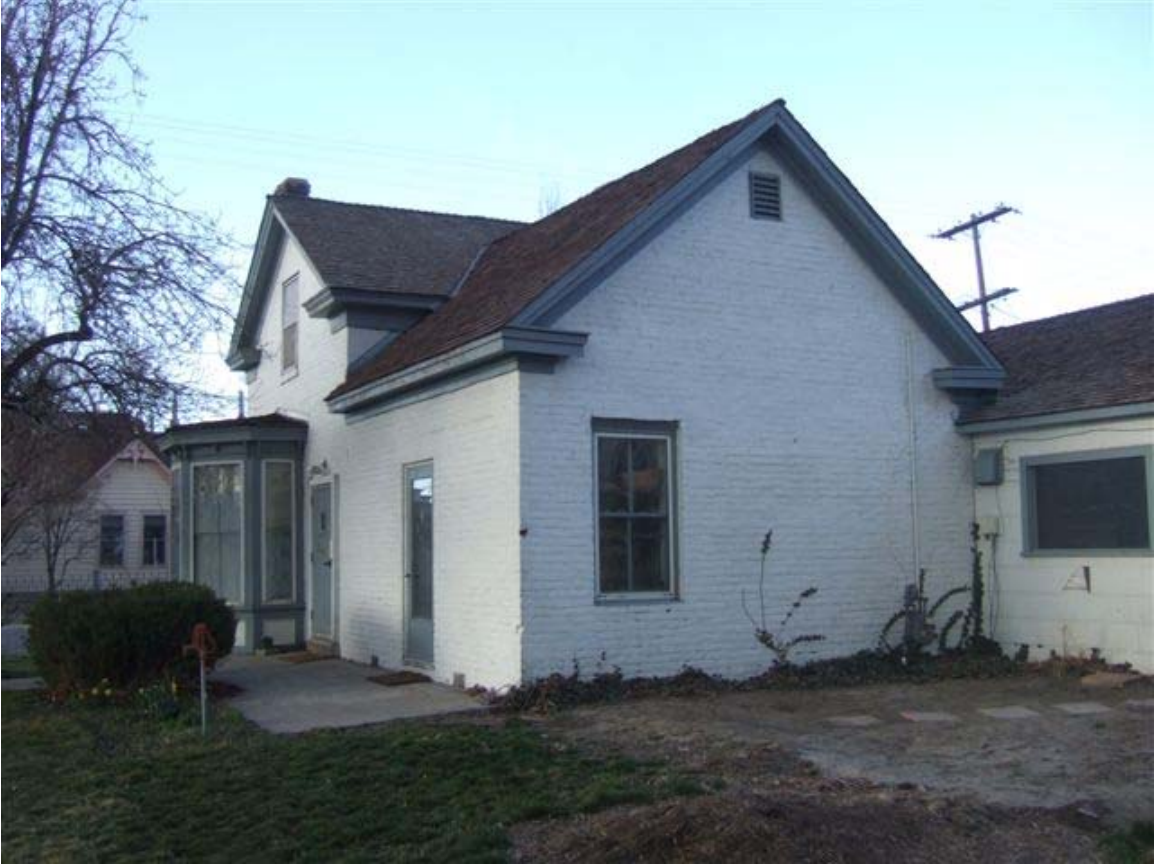
2. East (front) and north elevations of the Rectory.

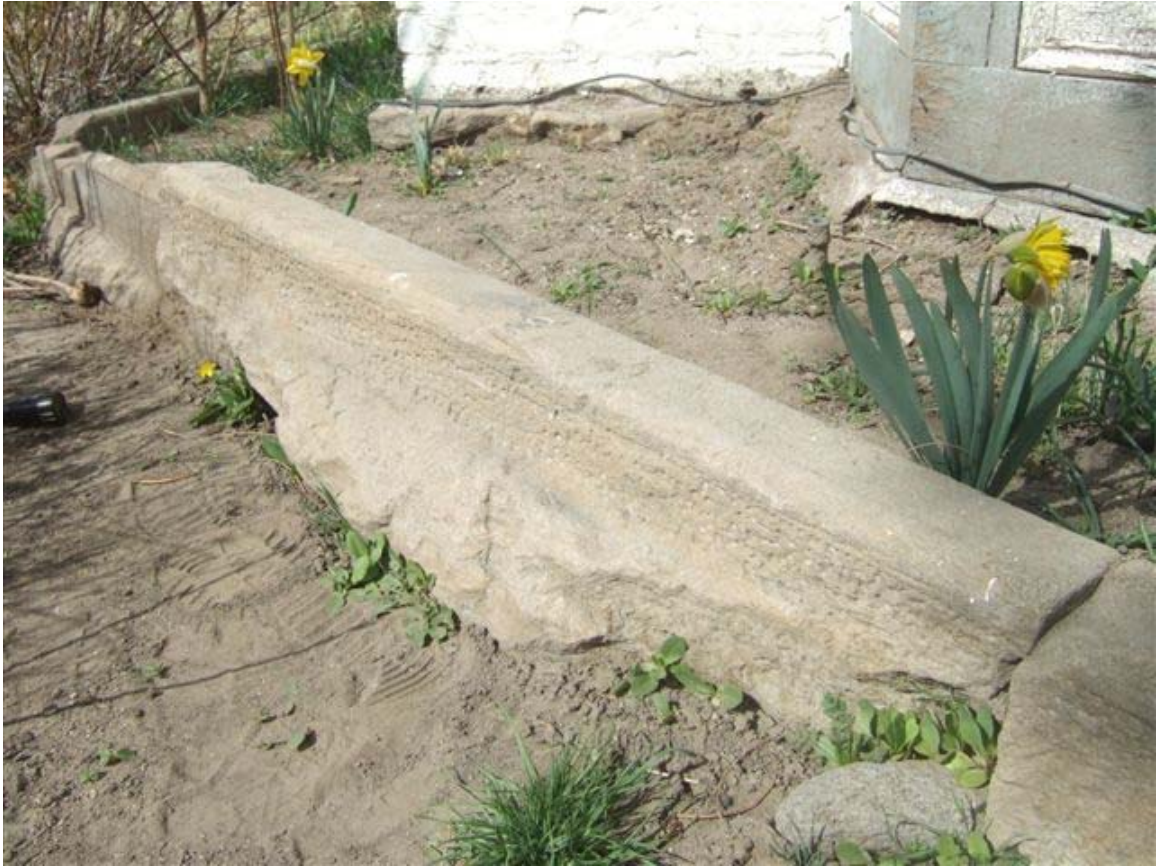
3. The Rectory's stone walkway and flower bed borders were probably added during the Hatch years.

The yard surrounding the Rectory preserves extensive nineteenth century walkway and planting bed borders. The borders consist of long stone blocks laid end to end. The blocks have narrow top faces with rounded edges. Some of the top faces have lengthwise bands with bush-hammered or otherwise tooled finishes bordered by chiseled dots; others are smooth. The most visible stone is located near the bay window and is angled with it. This stone—one of the smooth-topped ones—has a tooled outward-facing side that was meant to be seen and, below that, irregular quarryfaced or unhewn stone that was probably hidden below grade. This rougher stone projects and may have been intended as a sort of footer to anchor and steady the stone. Presumably the other stones have similar anchors for they are very regular after over a century in the ground. The stone borders line both sides of the front walk on axis with the entry to the main section, and also both sides of a walkway that passes behind the rear wing perpendicular to Proctor Street. They enclose a long rectangular planting bed that extends in front of a concrete pad that marks the location of the former front porch, and they form the edge of a foundation planting bed that wraps in front of the bay window, angles at the corner (as noted above), and continues along the south elevation to or nearly to the end of the rear wing. There are extensions at the angled corner and the north end of the front porch bed that may represent remnants of additional beds or yard divisions that are now underground or have

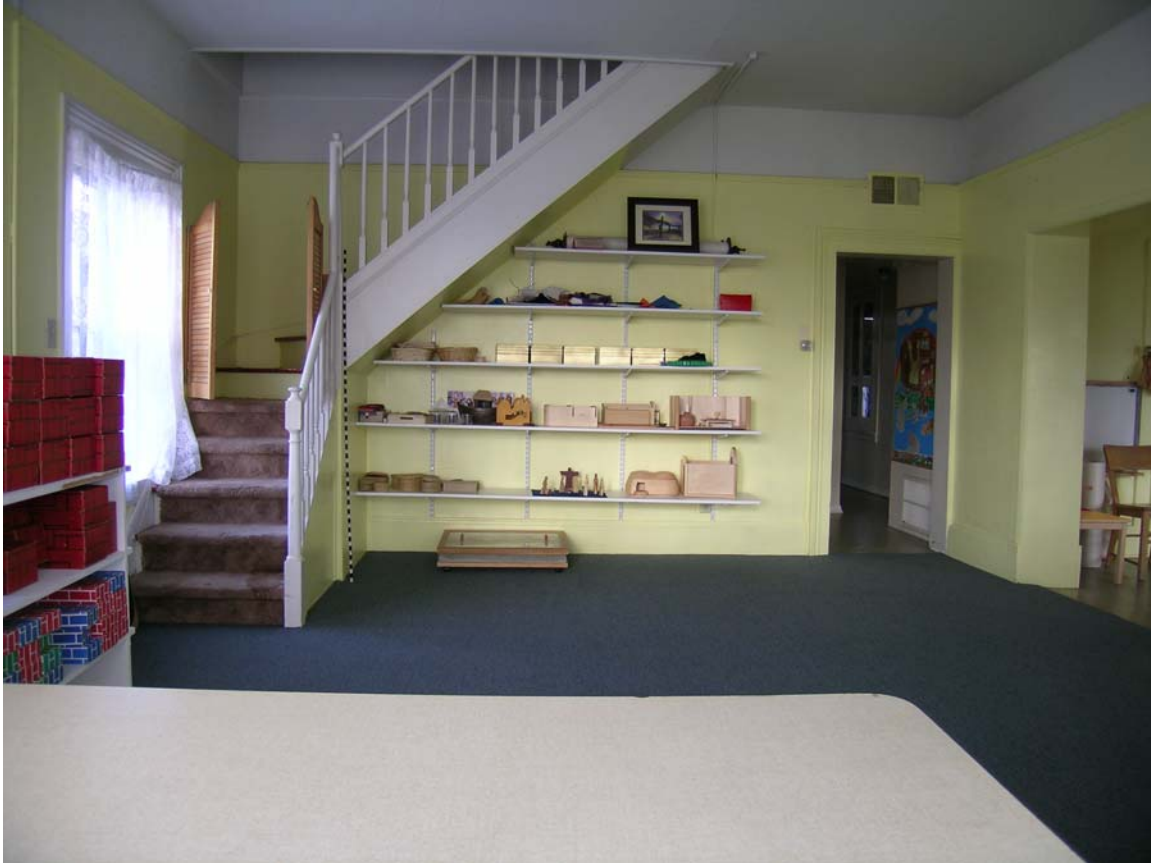
4. The Rectory's interior appearance dates in large part to renovations in the 1950s. This view of the room in the main section shows the 1950s stair.

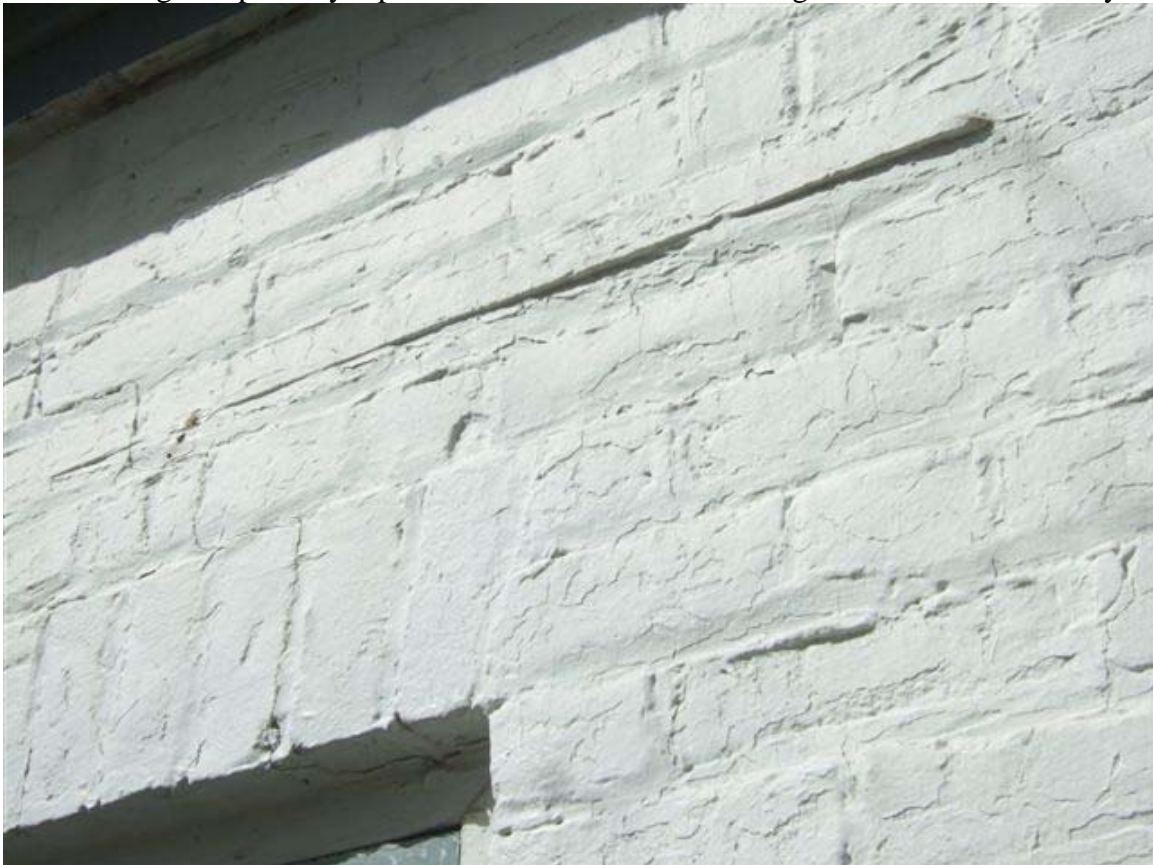
5. Rectory brickwork and front porch evidence (nailers).

**Recreate front porch.** The 1870s front porch was probably removed in the 1950s along with the other changes made at that time. The rationale probably involved mid-twentieth-century insensitivity to Victorian architecture and decorative elements and perhaps also deterioration and a desire to simplify maintenance. The fact that there is a concrete pad with the same footprint as the porch may indicate that the porch floor was removed first and the superstructure a number of years later. Likewise, the separate concrete in front of the main entry, which was originally covered by the porch, may indicate the section of the porch over the entry was removed first.

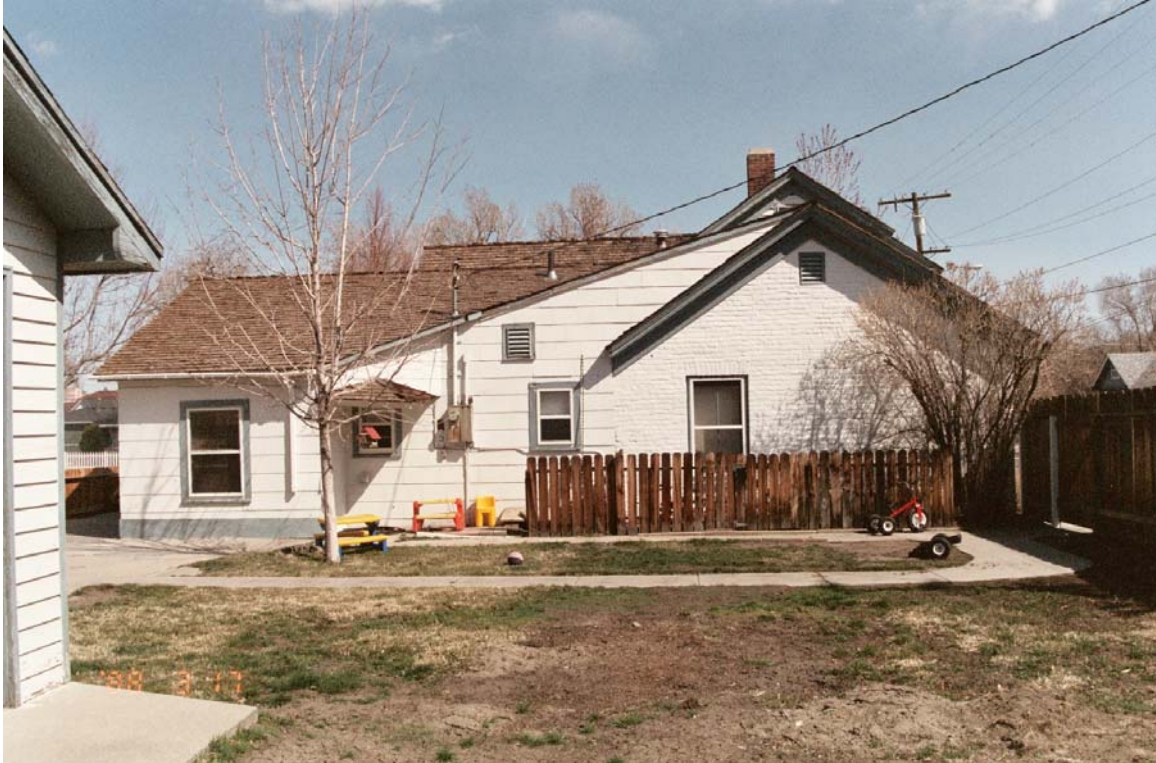
shingles over boards with v-section joints. There are plate glass windows at the wing's northeast corner that suggest a dining area immediately inside. A jog in the west elevation of the wing sheltered by an angled shed roof extension and a small cantilevered hip roof below probably results from the incorporation of a late nineteenth-century wing under the 1950s roof.

6. Rear (west) elevation.

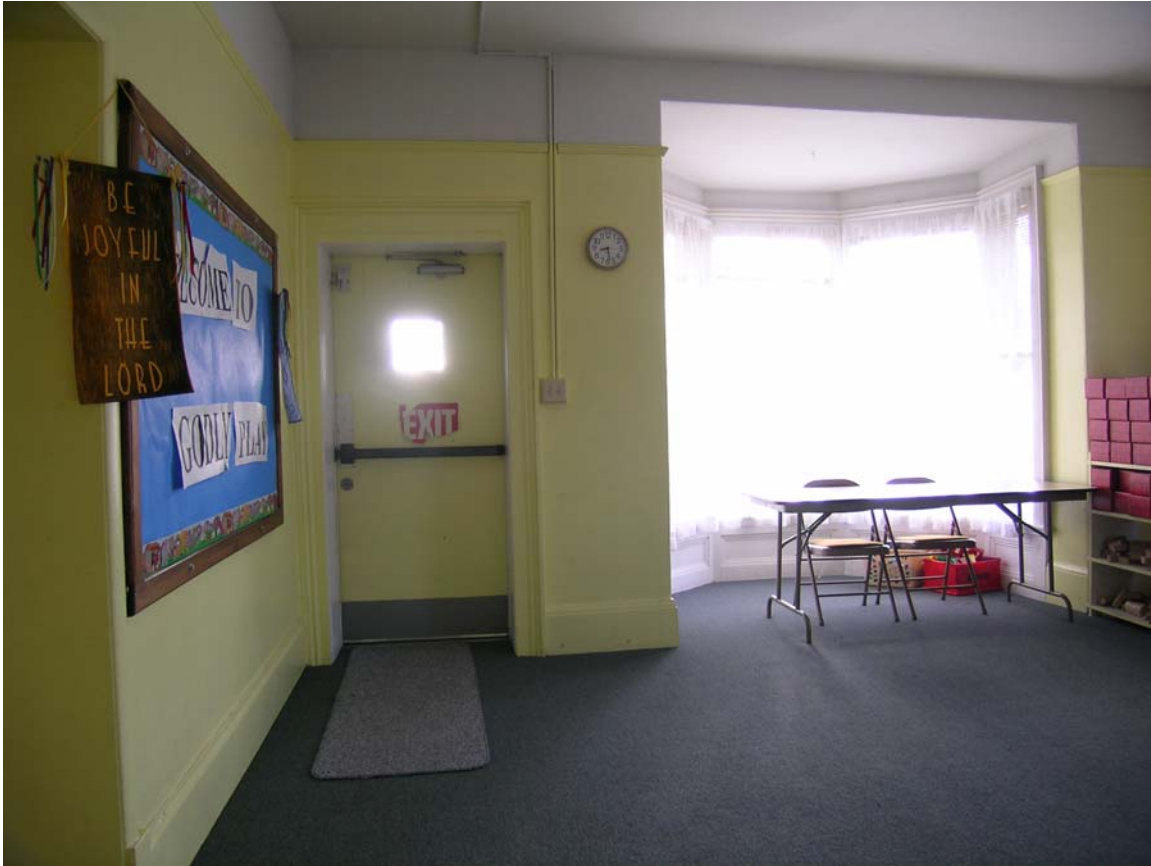
7. Front entry and bay window.

**Repair exterior woodwork.** The front bay window has a small amount of deteriorated woodwork. In accordance with the Secretary's Standards, ideally deterioration would be repaired either with pieced-in new wood or epoxy (Abatron or similar). If repair is impractical, replacement in kind with wood to match existing dimensions, moldings, etc. is appropriate. (There are signs that portions of the bay window have been repaired at least once in the past.) Dirt on the bottom of the bay window indicates splashback from rain which may be causing some of the peeling paint associated with deterioration or incipient deterioration. Low ground cover or other anti-splashback surface treatment may address the situation. For the rest of the bay window, maintaining a sound paint layer may help prevent deterioration.

**Replace main front door.** Explore options for a more appropriate door than the present one, which was presumably installed as a requirement of day care use. If allowable for the new use, a wood-framed glass door (similar to the storm door on the other front entry), or a wood panel door, perhaps with the upper half glass or (if four-panel) with two glass upper panels, are better options.

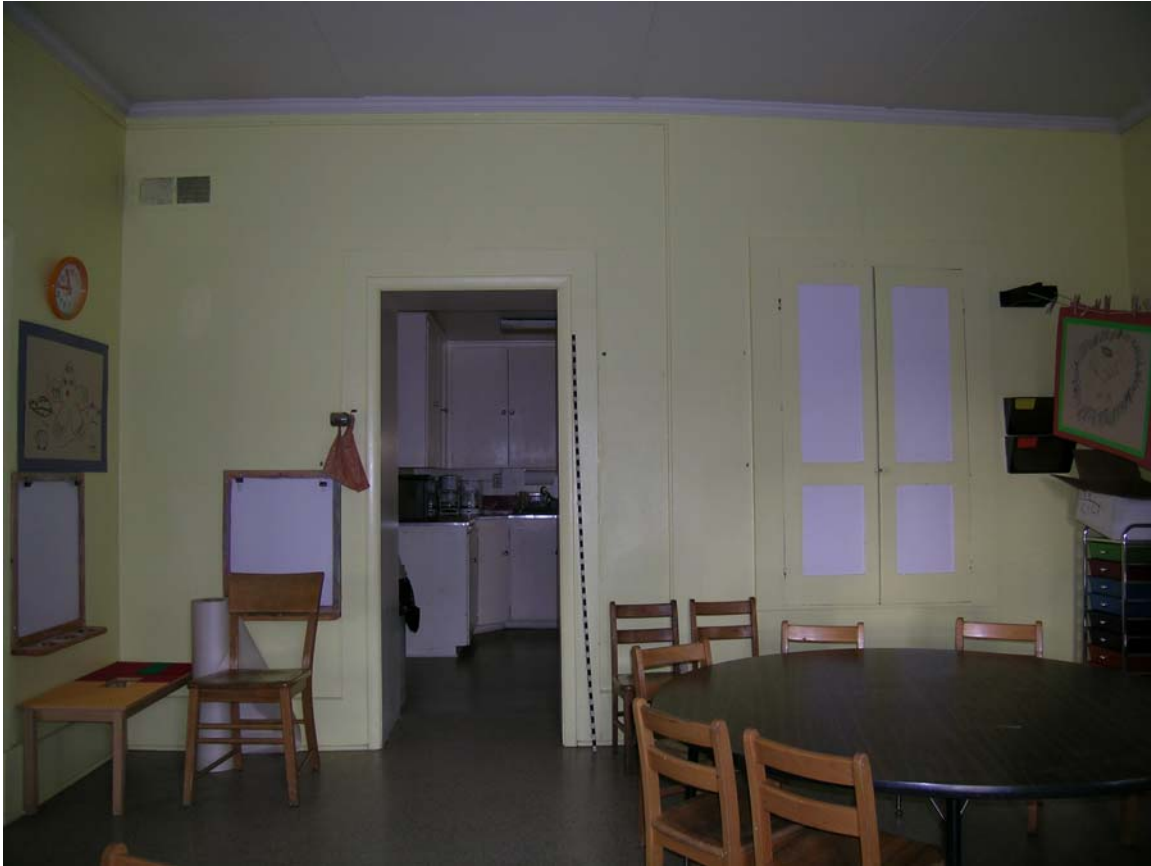
8. West or back wall of the side wing showing the built-in cabinet.

**Retain historic interior features.** These are few in number. Features that should be retained as is are the two built-in cabinets, nineteenth-century door and window trim, the trim and panels around the bay window, stove flues, and the tongue-and-groove cabinets in the upstairs room. The present stair (or most visible parts of it) dates to the 1950s, a period defined as non-historic for the Rectory, and it could be replaced; however it is attractive and serviceable and could be retained.

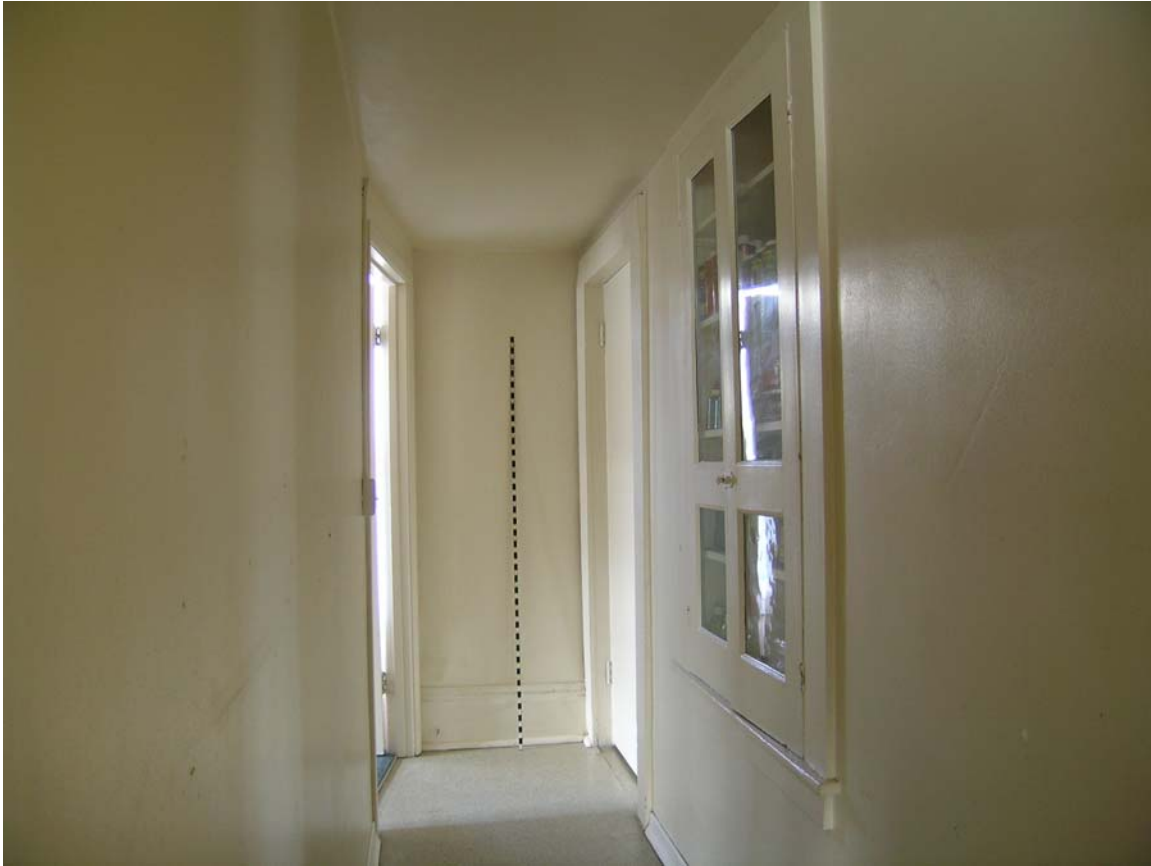
9. Hallway and built-in cabinet in the rear wing.

The present layout of the rear wing, which consists of a hallway and two bedrooms with closets, dates to the renovations of 1955 and/or 1956, although it is not impossible the wing was subdivided in the nineteenth century before it was made into a single room. The window sashes have metal pins for securing them in place. A glass-fronted cabinet converted from a north-facing window suggests the room was converted to a dining room in the late nineteenth century. Like the cabinet in the side wing it has a beaded tongue-and-groove backing with evidence of green paint before the present white. The cabinet now opens into the hallway, which has a ceiling lower than that in the two bedrooms, and a plywood furnace enclosure at its east end. The furnace enclosure preserves evidence of historic wallpaper and paint described below. The interior of the rear frame wing dates almost entirely to the mid-1950s and later, although a frame-like feature at about the midpoint of the kitchen relates to the former exterior wall of the smaller nineteenth century wing. The kitchen base cabinets have red formica or formica-like countertops and splashbacks, aluminum trim and drawer and door pulls, a lazy susan at the corner, and a modernistic design of parallel lines on the panel under the sink. The fluorescent light over the sink has a modernistic perforated metal shade.

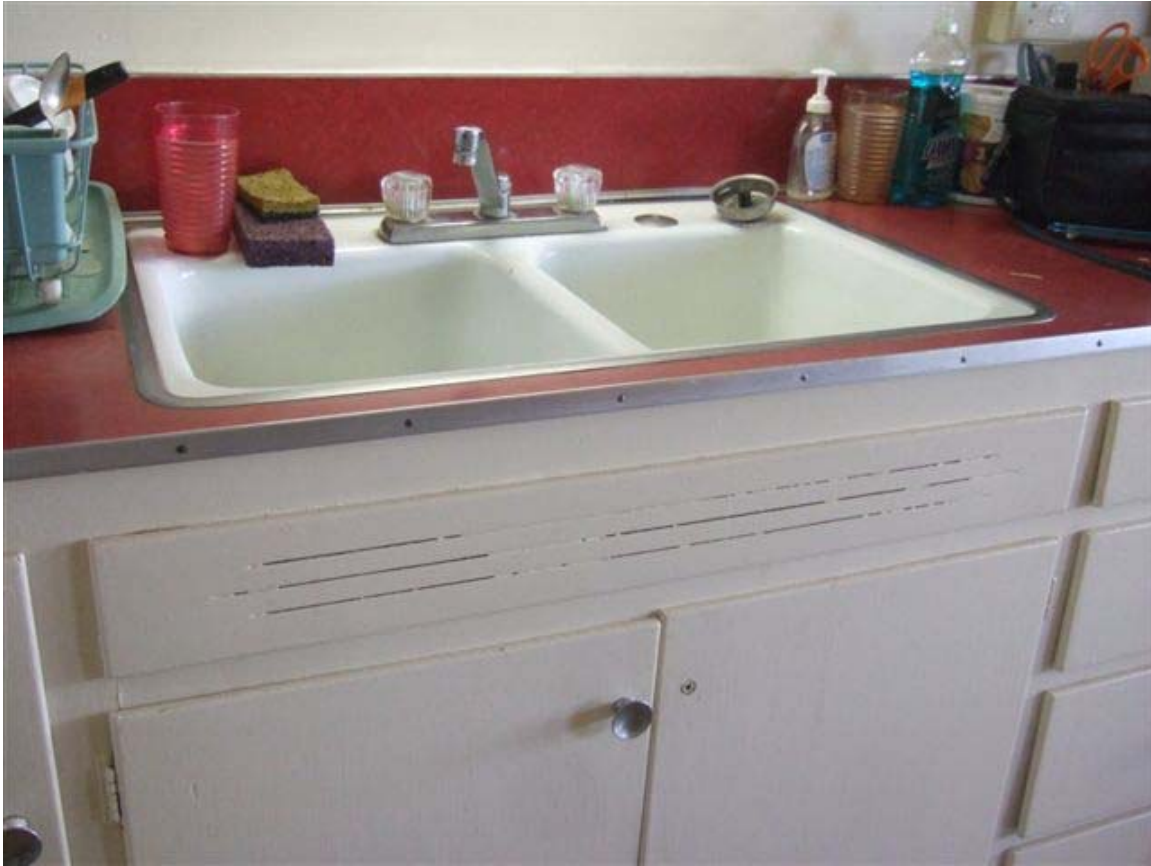
10. Kitchen sink and cabinets.

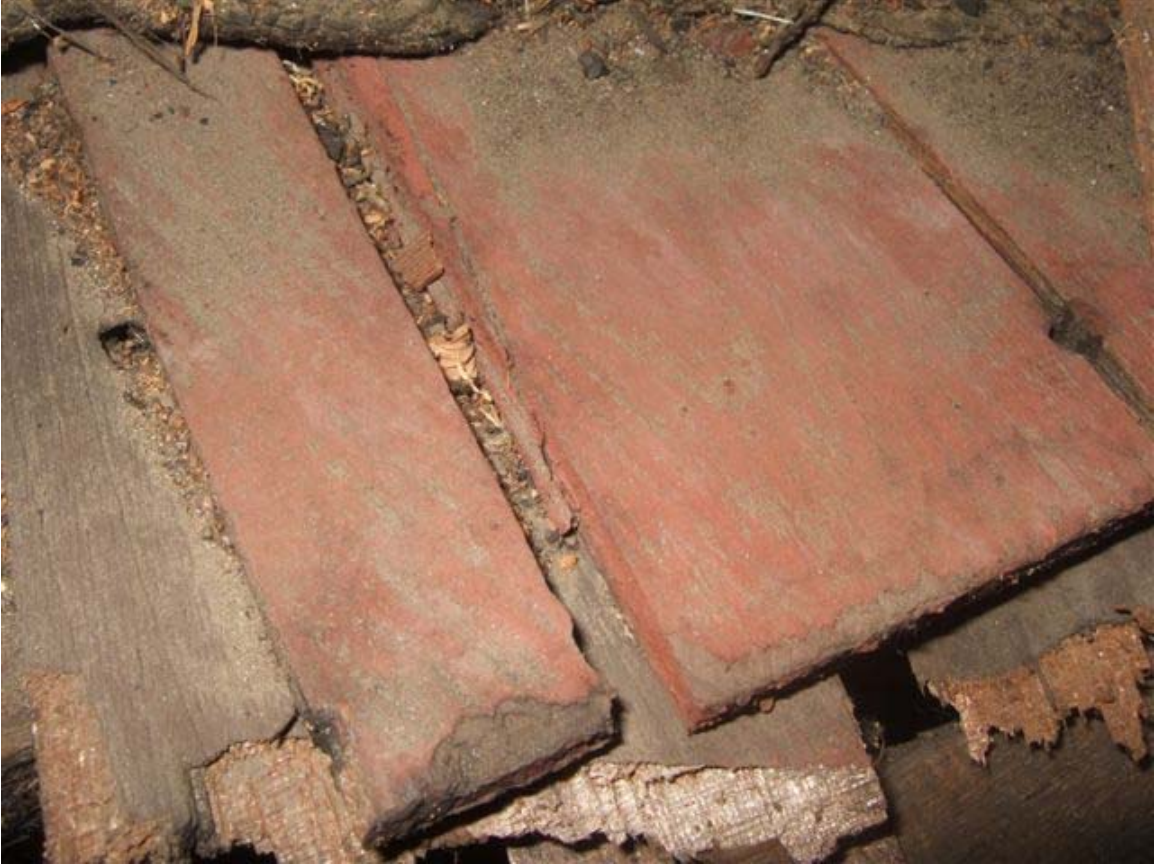
11. Red-painted wood roof shingles preserved in the attic.

The attic is a virtual time capsule of early exterior features and finishes, and provides as well some information on interior finishes. The attic has four sections, one each over the side and rear wings and two over the rear frame wing corresponding to the original construction of that wing and its extension in the 1950s. The roof structures of the wings (the main section roof structure is not directly visible) consist of butted and nailed common rafters. The roof over the rear wing also has collar boards, a structural feature known to exist in the main section roof as well. Sections of wood-shingle roofing are visible over the main section, the side and rear wings, and the original section of the rear frame wing. The shingles on the rear frame wing's shed roof are painted red whereas those on the earlier sections of preserved roofing have a natural weathered gray color. Knob and tube wiring in the attic presumably dates to 1900 when the Rectory was electrified.

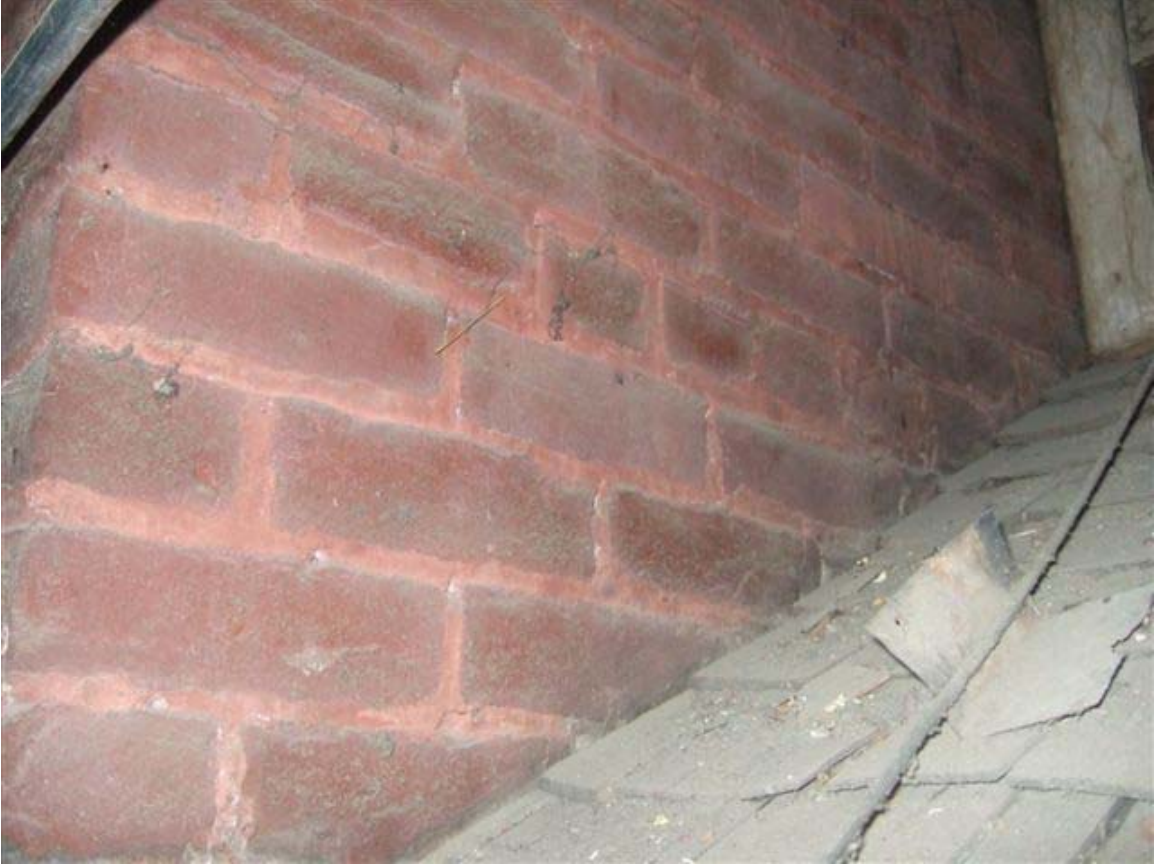
12. Red oxide wash visible in the attic.

Two treatments are visible on the sections of formerly exterior brick wall visible in the attic or, in the case of the north elevation of the rear wing, visible looking down into a wall cavity from the attic. The bricks of the main section and side and rear wings were originally left unpainted. At some point before the addition of the rear frame wing (added by 1885) the main section was painted with a red oxide wash over the bricks and mortar. The mortar joints were not penciled as part of this treatment. The sections of cornice and frieze board on the north elevation of the main section are unpainted where they were encapsulated in the side wing attic, whereas those sections outside the side wing attic are painted white. The cornice and frieze board on the rear elevation of the side wing were also painted white. (Photographic evidence suggests the Rectory's trim was painted white prior to the summer of 1871.) The topmost molding of the side wing cornice has a yellowed appearance that could indicate it was painted an ocher color, although the color may be a result of staining from the roof shingles or some other non-intentional factor. The roof added to the rear frame wing in the mid-1950s is lightly constructed and has purlins of reused lumber to support the rafters. This roof has a roof hatch and a bare bulb fixture of brown material, probably Bakelite. Knob and tube wiring is visible throughout the attic.

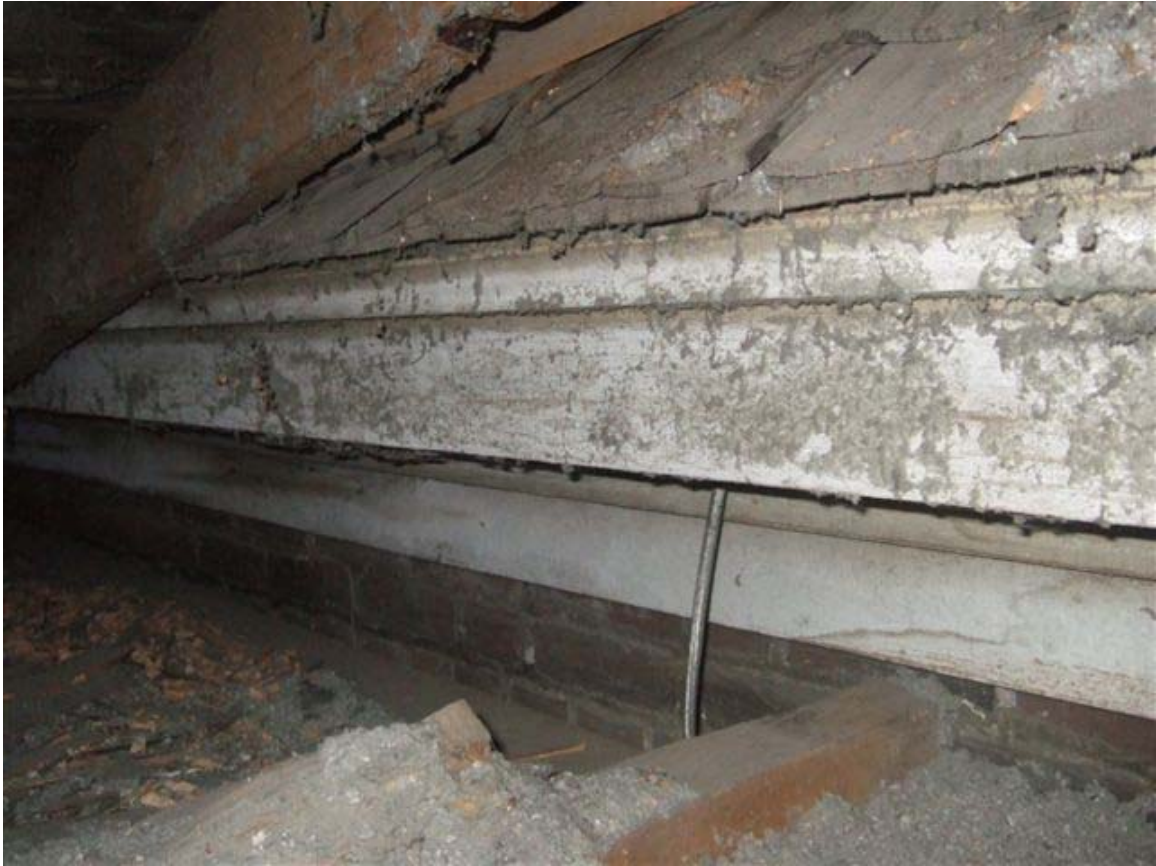
13. Formerly exterior west (rear) elevation cornice of the side wing.

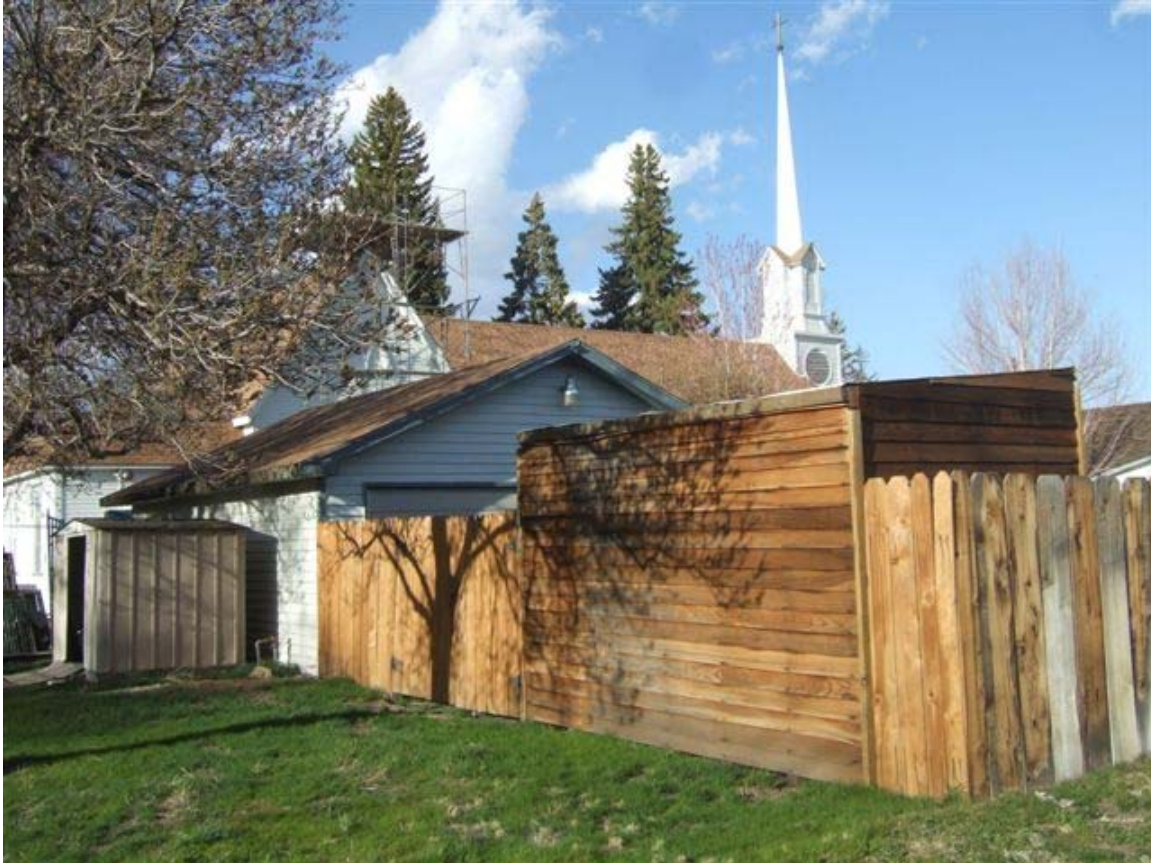
14. Garage and storage shed.

Behind (west of) the Rectory along Minnesota Street stand a garage and a storage shed, both modern one-story frame buildings. The garage has an asphalt-shingled gable roof, painted weatherboard siding, a concrete foundation, and two garage bays on the south gable end with replacement roll-up doors. There is a wood and glass panel door on the east side flanked by aluminum-frame windows. The interior has a concrete slab floor, plywood wall sheathing, and exposed rafters. The shed has unpainted weatherboard siding, a shallow-pitched shed roof, and a z-braced door. The garage and shed connect to a modern board fence that encloses the back yard, which was used until recently as a preschool play area. A portable metal shed stands between the garage and Minnesota Street.

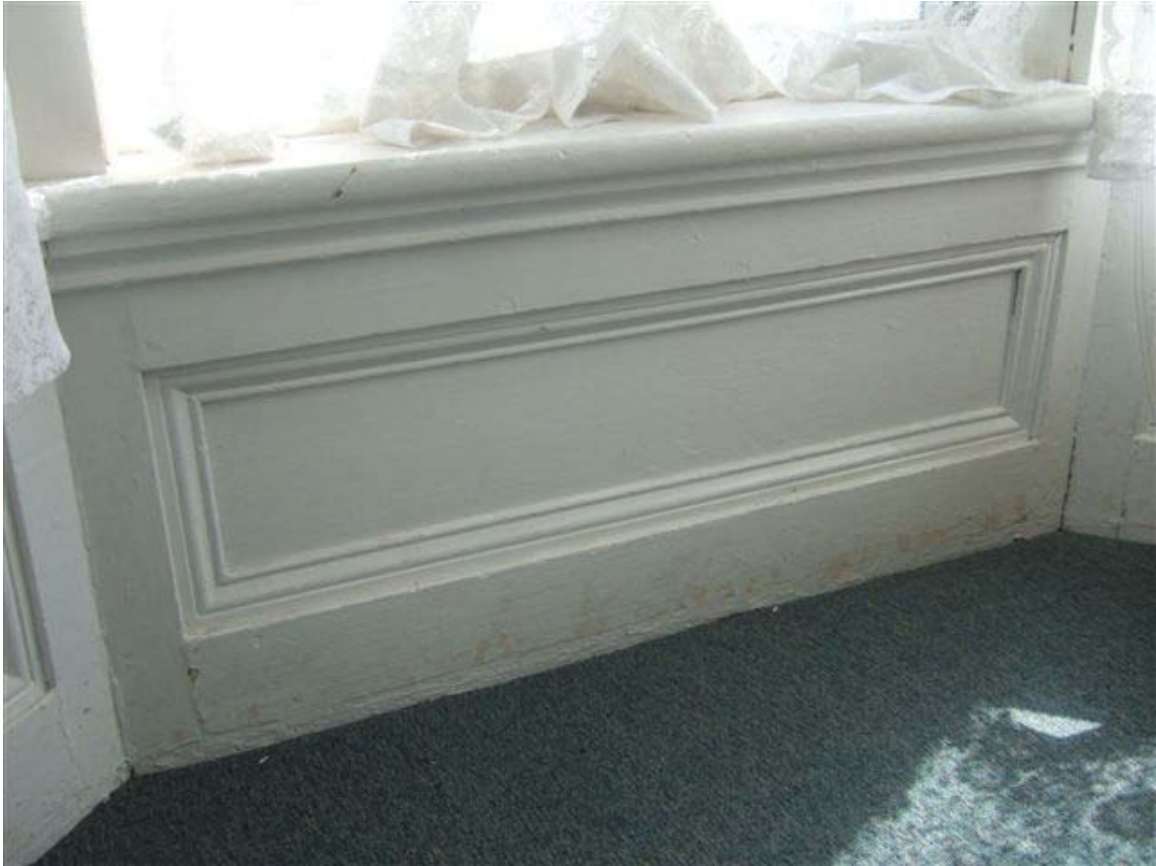
16. Bay window apron panel.

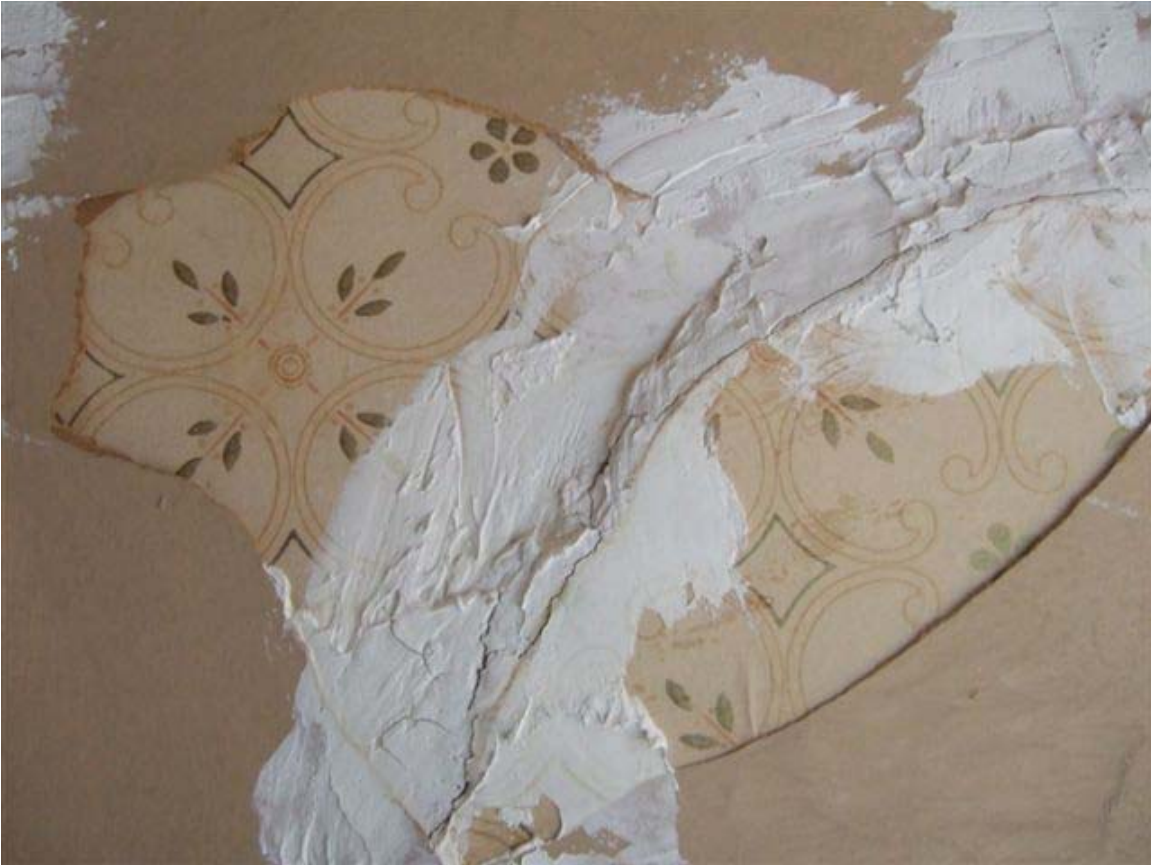
17. Wallpaper in the upstairs storeroom.

Vestiges of historic finishes survive throughout the interior. The upstairs closet/small room preserves nineteenth-century wallpaper—possibly the original paper in the space—

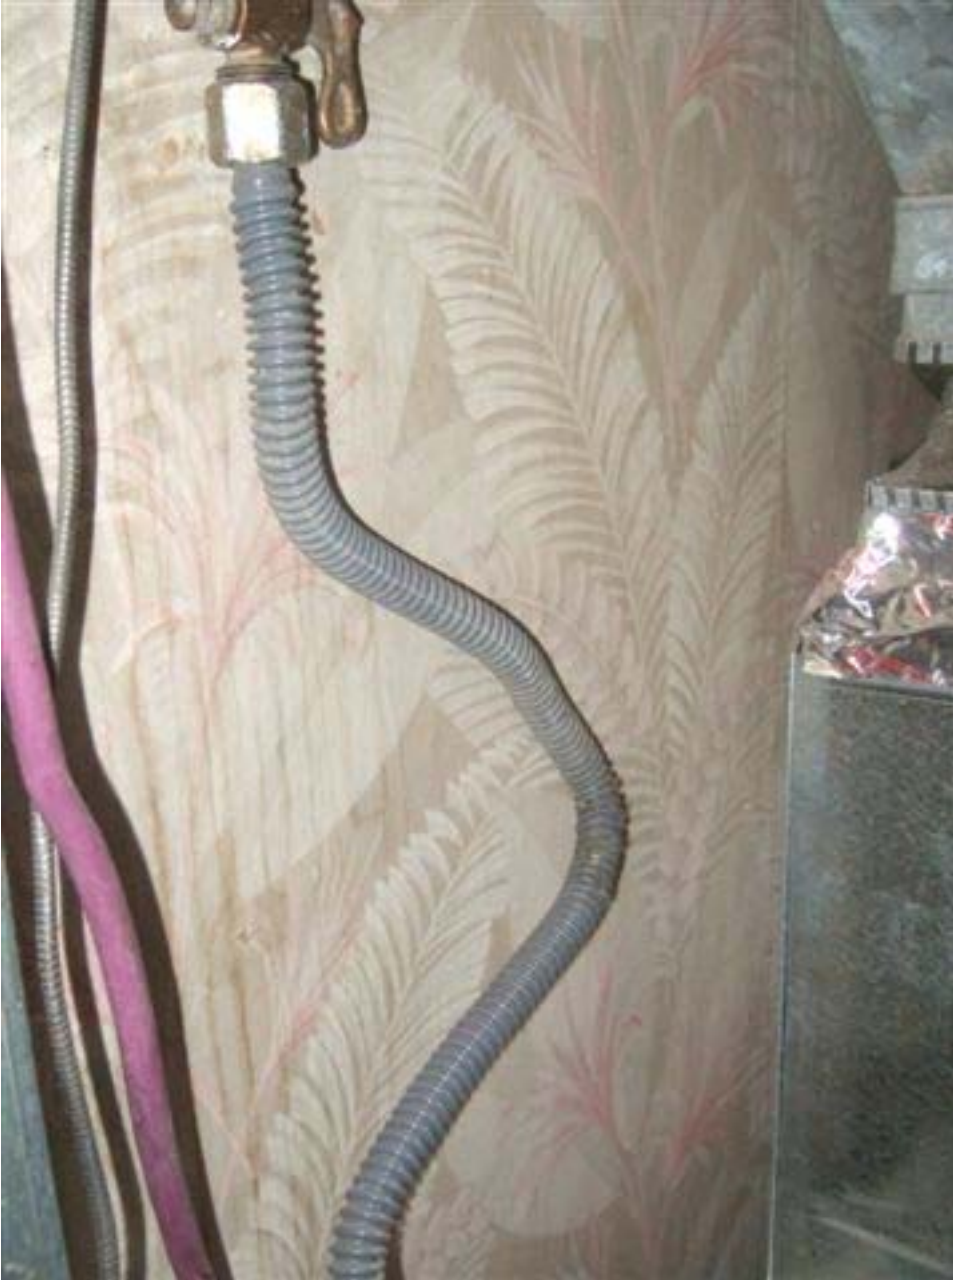
18. Wallpaper in the rear wing furnace enclosure.

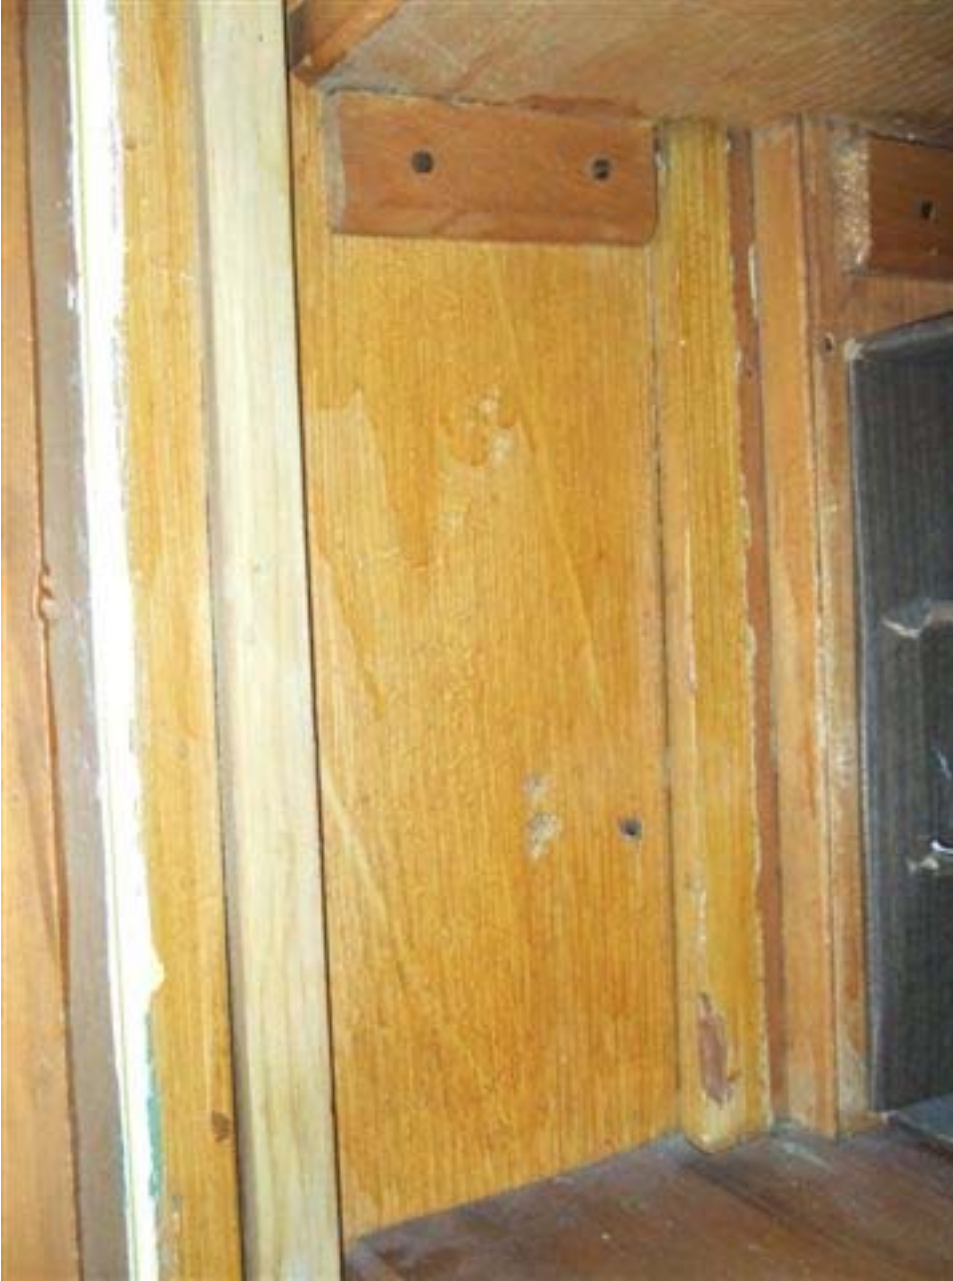
The built-in cabinet in the side wing preserves yellow nineteenth century graining in imitation of clear pine wood. The simply combed graining appears to pre-date the conversion of the window into a cabinet (the cabinet shelves, supports, and backing are not grained), and it appears to have been painted over earlier white paint. This evidence may indicate that the window/cabinet trim was painted white in the early or mid-1860s and then grained—perhaps during the early years of the Hatch ownership beginning in 1872—before the window was converted to a cabinet in the 1880s or early 1890s. Assuming this chronology is correct, the interior doors and trim throughout the house may have been painted white initially and then grained in the 1870s as part of the Hatch family improvements. Ornamental hardware features such as the latches on the cabinets

19. Graining in the built-in cabinet of the side wing.
